Manhole Inspection Summary

Manhole # S45E__051MH

Insp Date: **2/12/10 12:28 PM**

Location Address: **31 N. Ann St.**

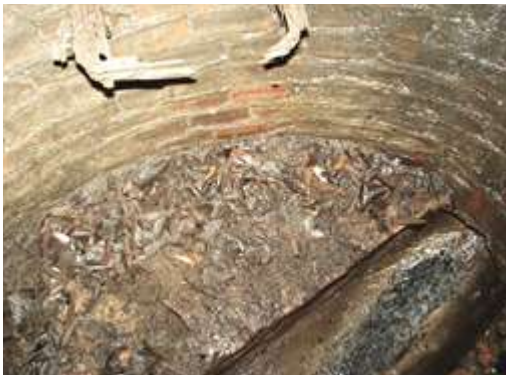
Defect 3

Condition: ☐ Sound ☐ Cracked ☐ Root Intrusion ☐ Deteriorated ☐ Leaks ☒ **Debris**

debris

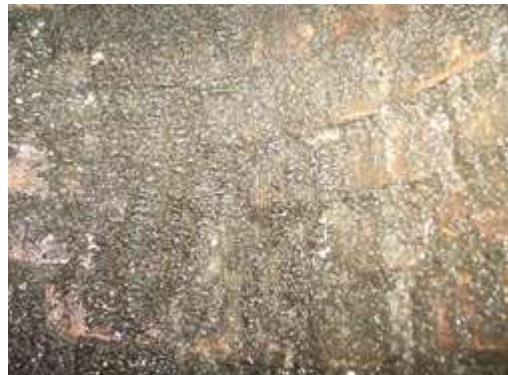
Defect 2

infiltration

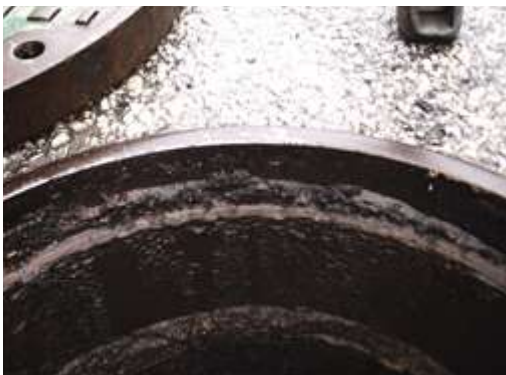
Defect 1

Frame Offset: **1** (in.) Condition: ☐ Sound ☐ Cracked ☒ **Leaks**

frame leaks

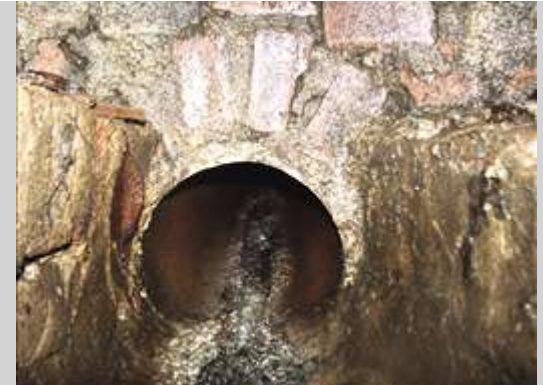
12 O'Clock Outflow

8 in. Circular Gravity Sewer
Pipe Out @ 12 O'Clock

Pipe Height: **12** (in.) Rod and Bar (Angled)
Pipe Material: **Clay** ☐ Pipe Lined
Invert Depth: **11.25** (ft.) Flow Characteristics: **Fast**
Deposits: ☒ None ☐ Mud ☐ Sludge ☐ Debris ☐ Grease
Silt Depth: (in.) Deposits Extent:
Infiltration: **None** Pipe Seal Cond: **Sound**

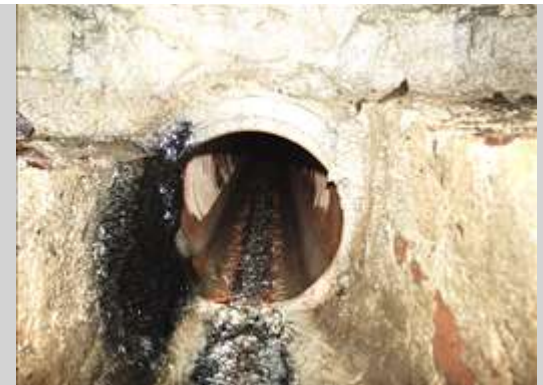
6 O'Clock Inflow

8 in. Circular Gravity Sewer
Pipe In @ 6 O'Clock

Pipe Height: **12** (in.) Rod and Bar (Angled)
Pipe Material: **Clay** ☐ Pipe Lined
Invert Depth: **10.67** (ft.) Flow Characteristics: **Fast**
Deposits: ☒ None ☐ Mud ☐ Sludge ☐ Debris ☐ Grease
Silt Depth: (in.) Deposits Extent:
Infiltration: **None** Pipe Seal Cond: **Sound**
